20. ABSTRACT (Continue on reverse side if necessary and identify by block number) Cane Creek Watershed Dam No. 19 is a linear earthen structure 2 550 feet long and 20.9 feet high with a crest width of 13 feet. It has upstream and downstream slopes of 1V:2.6H and 1V:3.1H respectively. The lake has 2.194 acre-feet of available flood storage, but it normally remains empty nine months out of the year. The reservoir has a drainage area of 3 315 acres (5.18 mi 2). It is predominantly farm and pastureland with an average ground slope of approximately 4%. The dam has a relatively uniform cross-section along most of its length. The crest undergoes little change in elevation and has a fairly constant width.

PHASE I INSPECTION REPORT
NATIONAL DAM SAFETY PROGRAM
TENNESSEE

Name of Dam Cane Creek Watershed Dam No. 19
County Lauderdale
Stream Hyde Creek - Tributary of Cane Creek
Date of Inspection March 12, 1981

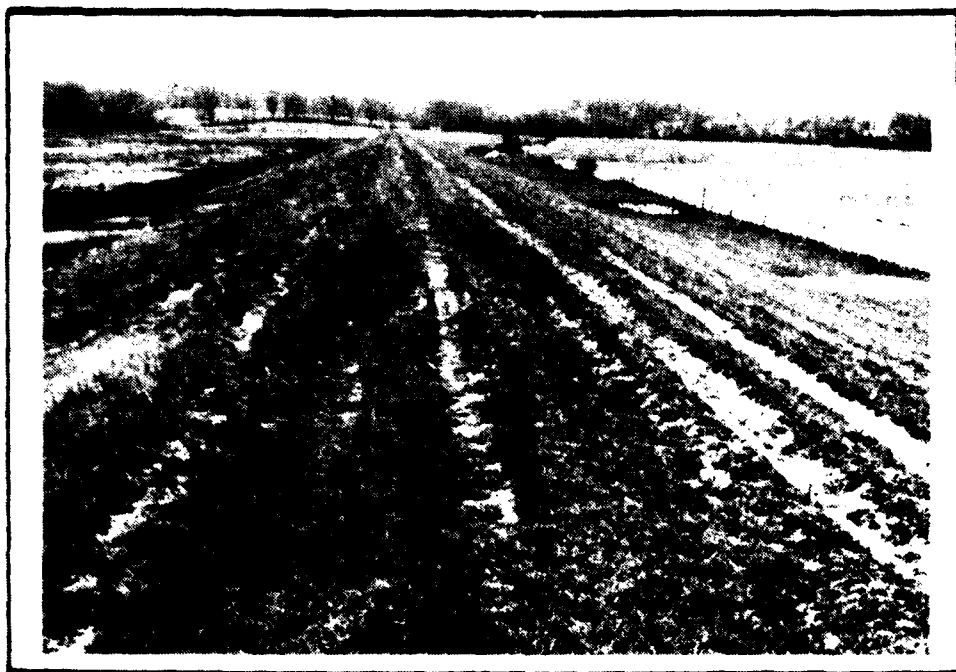
PHOTO NO. 3

- Photo No. 1 - Aerial shot from downstream of dam.
- Photo No. 2 - Aerial shot from upstream of dam.
- Photo No. 3 - Dam crest looking left from near right end.

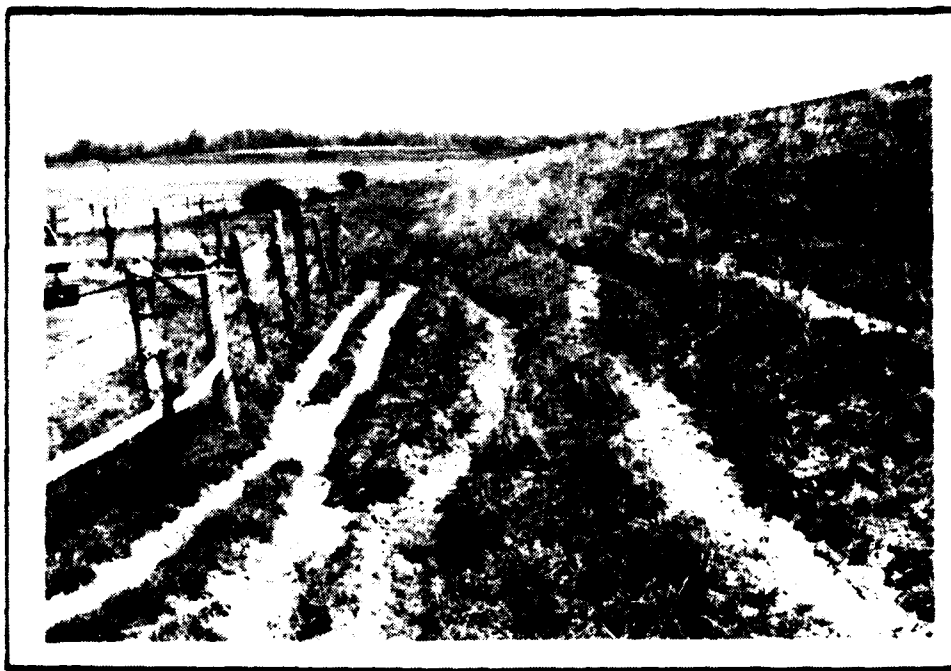
PHOTO NO.9

Cattle traffic along the downstream slope has covered much of the surface with small superficial depressions, and the trails paralleling the dam create a stepped appearance in many locations (see photo nos. 7, 8, 9, and 10). A few larger depressed or eroded areas appear sporadically along the slope. They appear to have been initiated by cattle also, and are not deep enough or cover a large enough area to warrant concern (see photo no. 7).

- Photo No. 9 - Trails from vehicular and cattle traffic along dam toe at midsection.
- Photo No. 10 - Pooled surface runoff at toe left of center.
- Photo No. 11 - Plunge pool and natural stream channel.

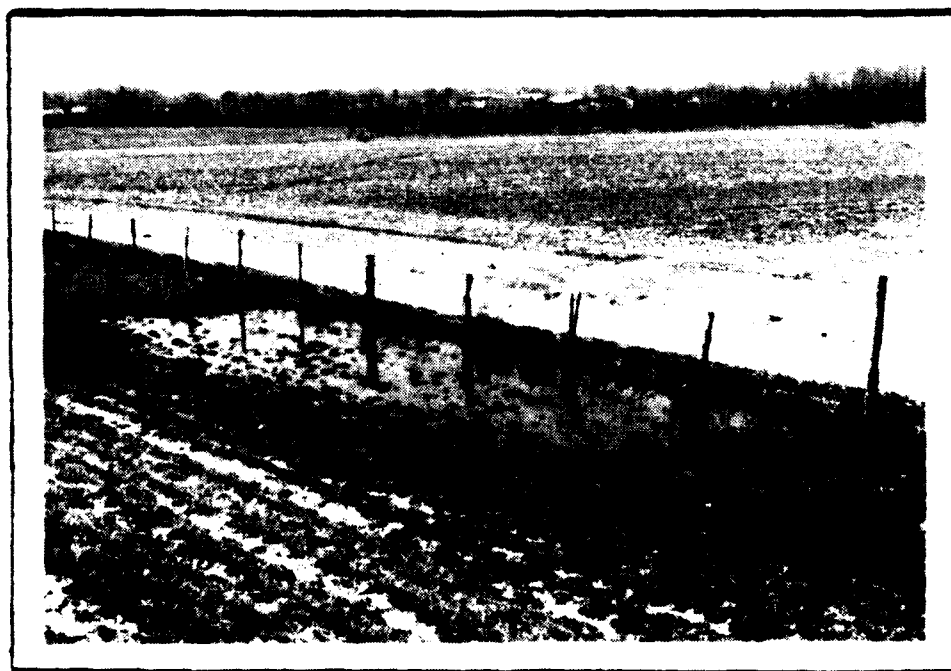
PHOTO NO.10

No indications of seepage were observed on the embankment or in the area immediately downstream. A few wet areas do exist along the toe, however, their restriction to low lying areas indicates that they are probably due to pooled surface runoff (see photo no. 10). Impounding water at the sediment pool level for only a few months out of the year gives the embankment little opportunity to develop seepage problems.
